TREX 300 Spirit2

FW 3.0 (no changes to heli nor settings after upgrade from 2.8)

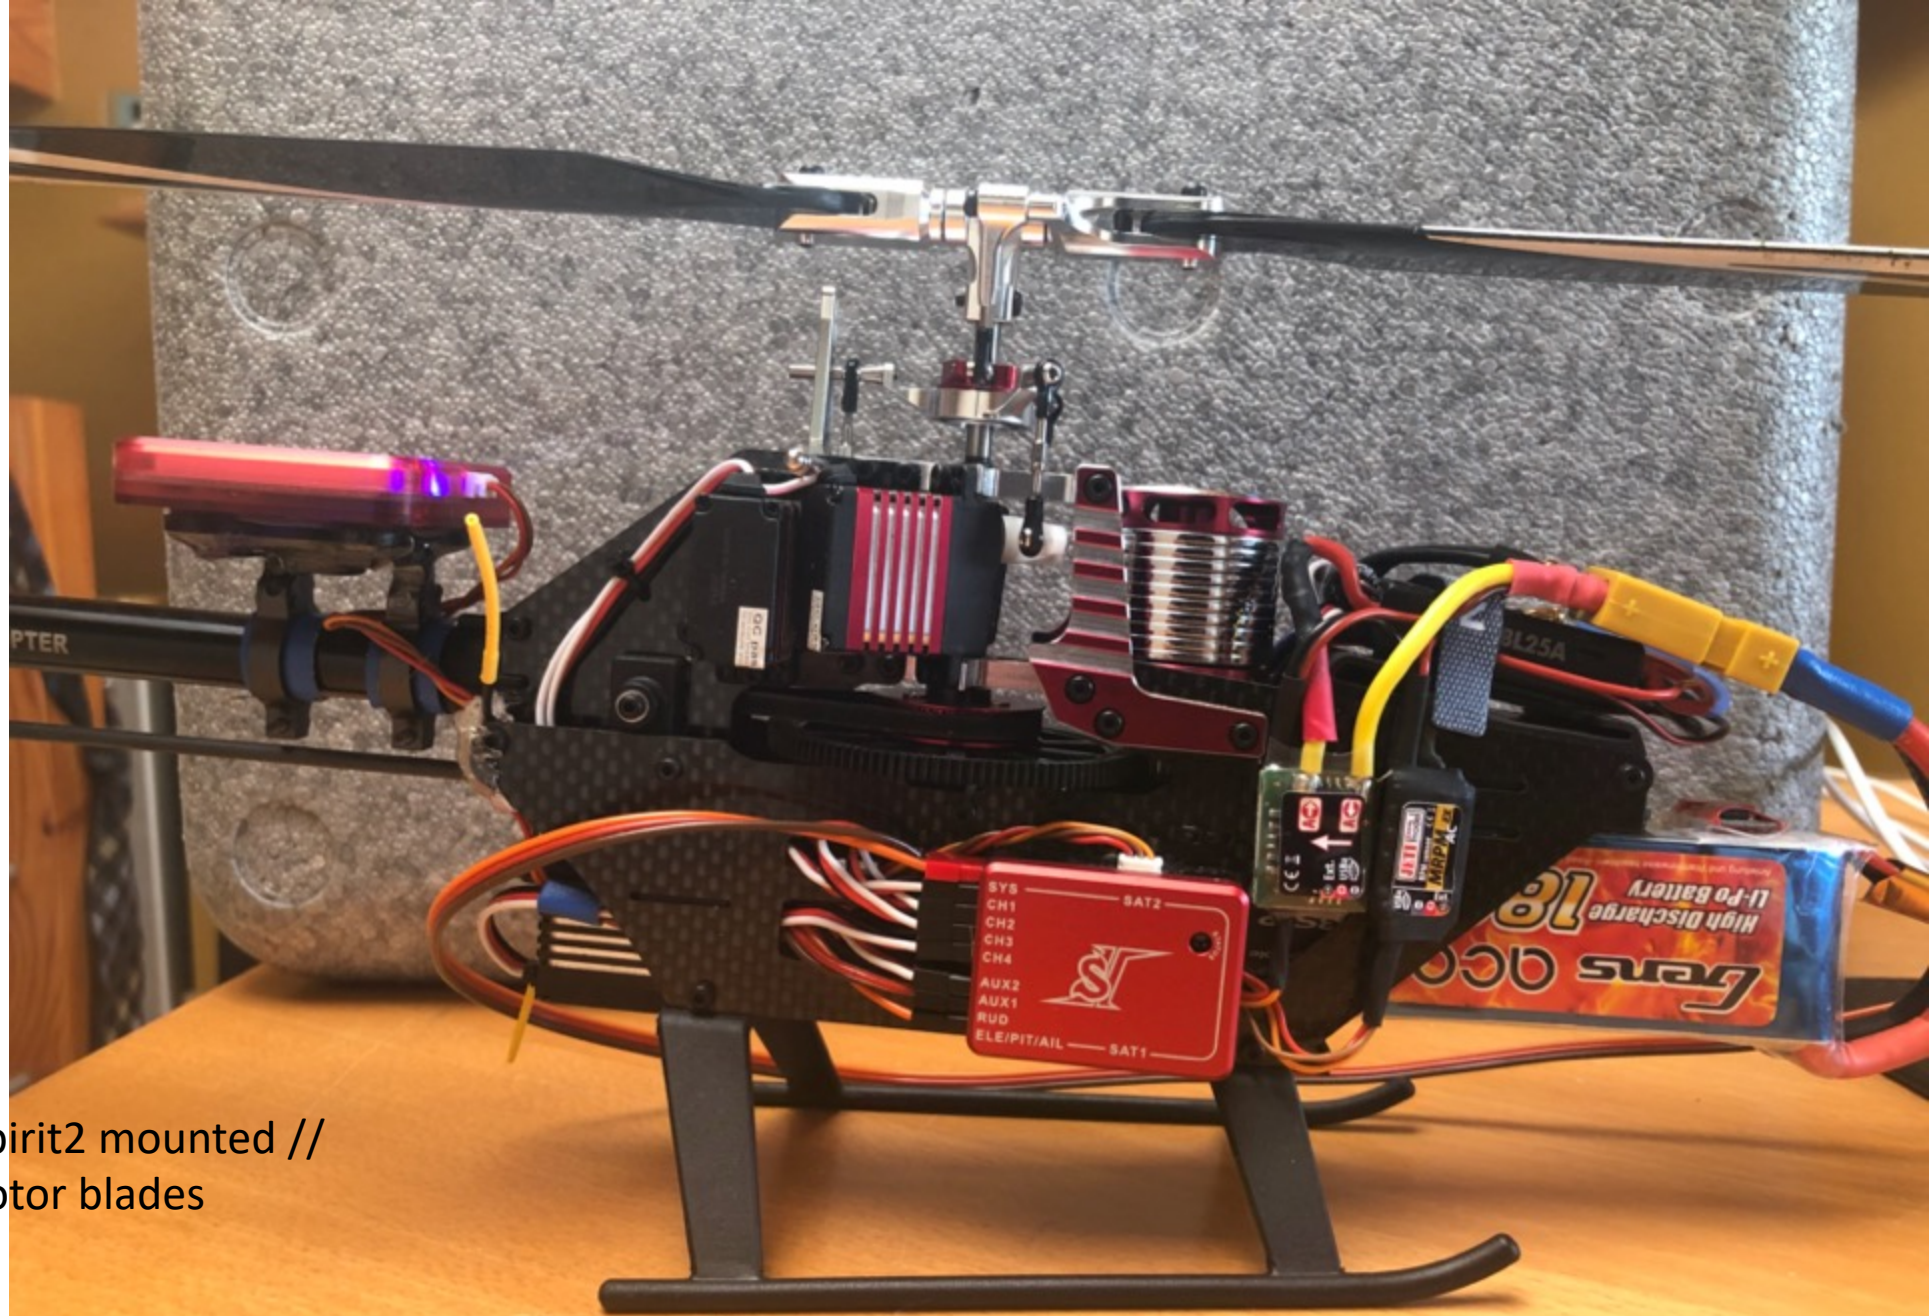
Unit spirit2 mounted //
with rotor blades

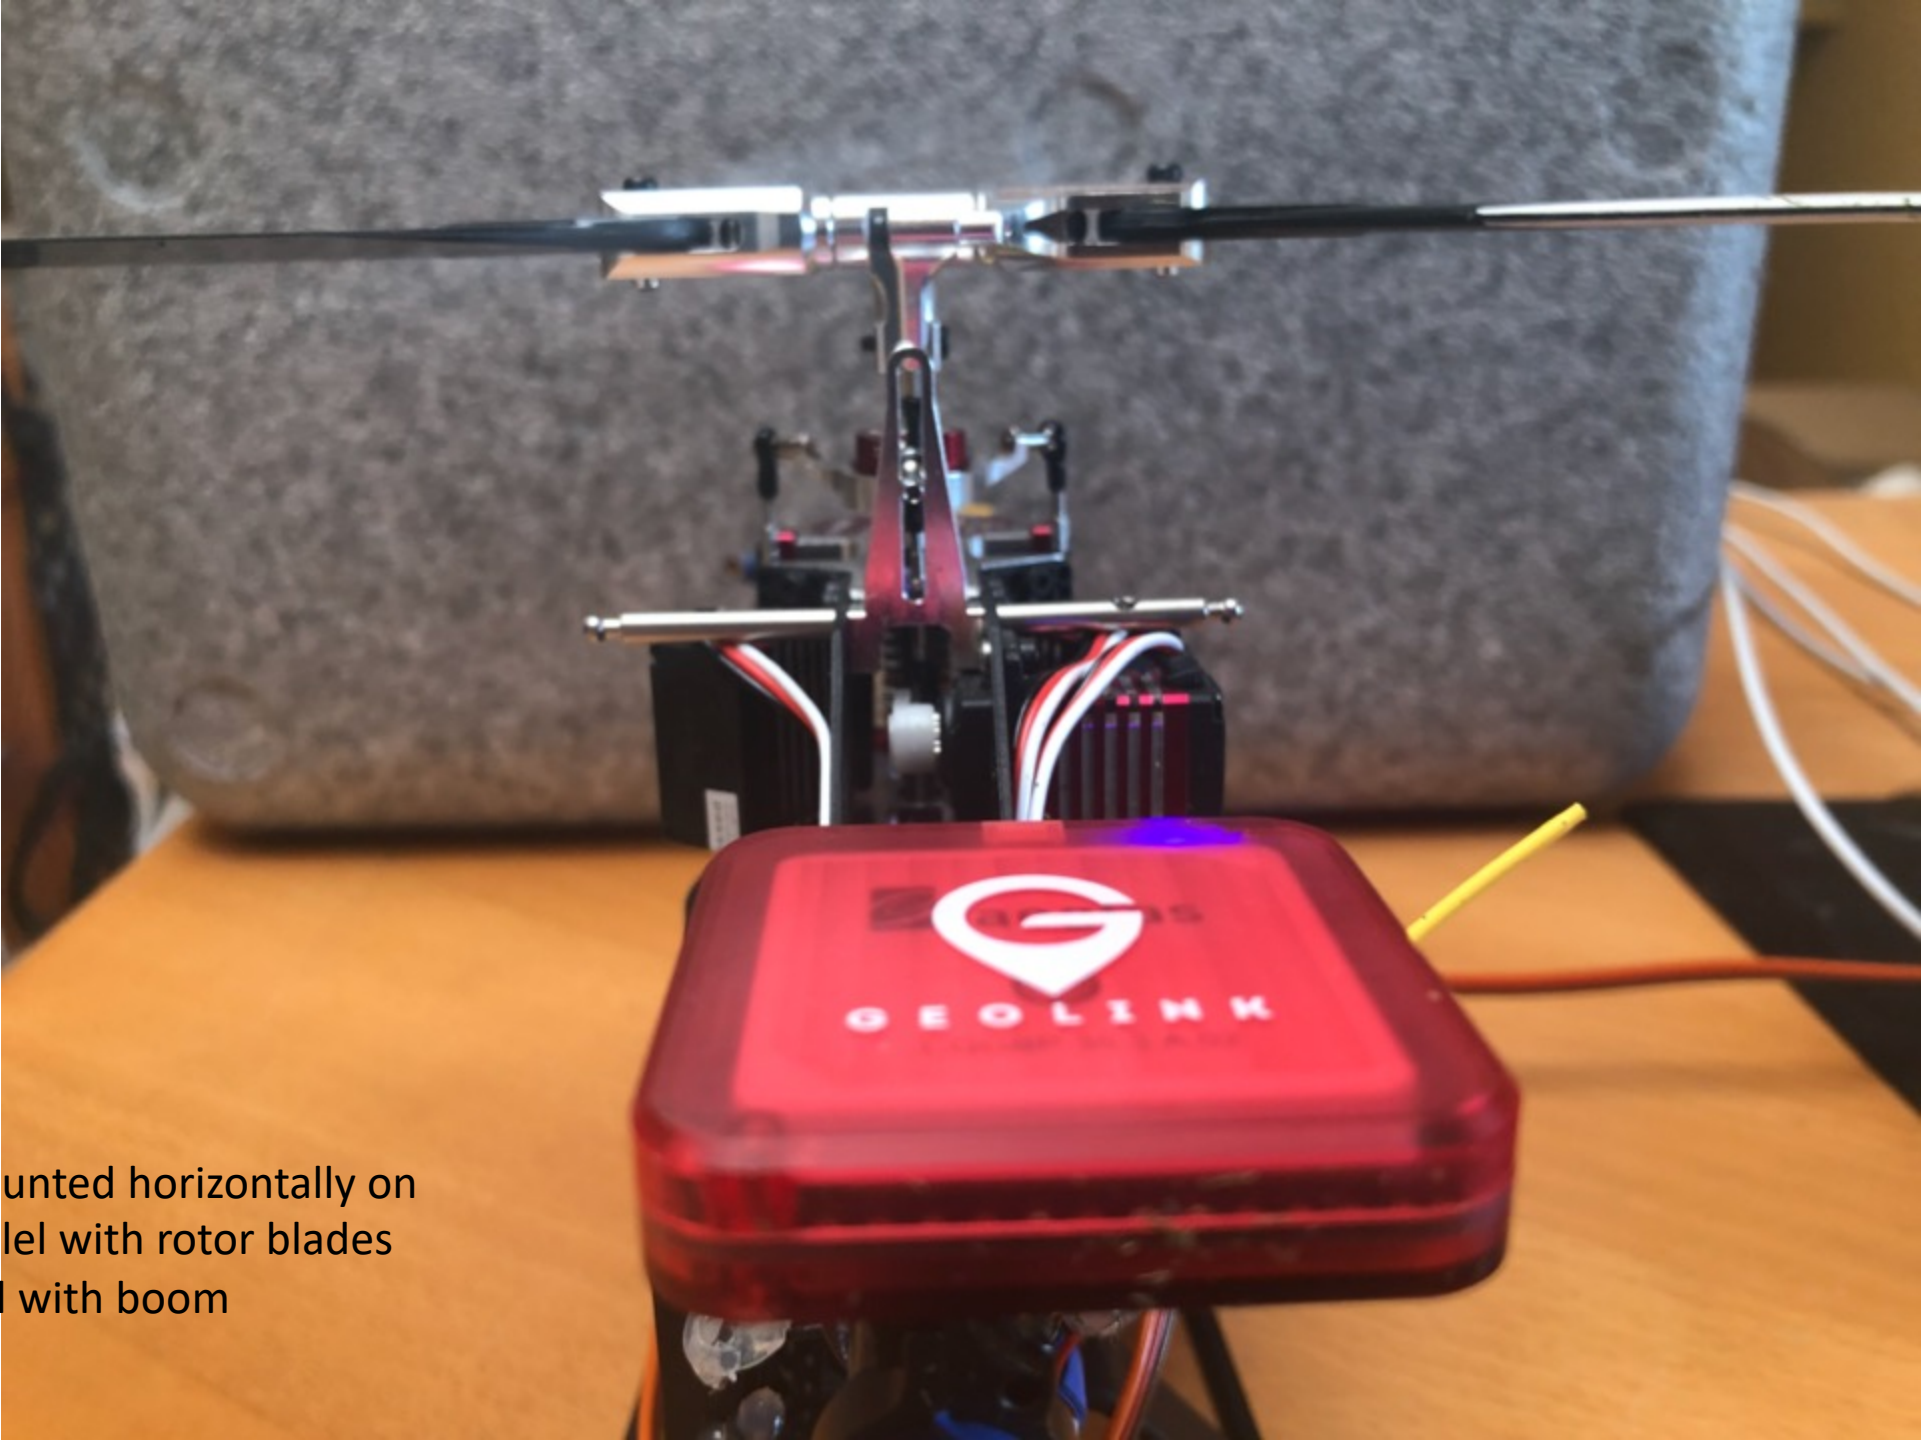
Geolink mounted horizontally on boom parallel with rotor blades and parallel with boom

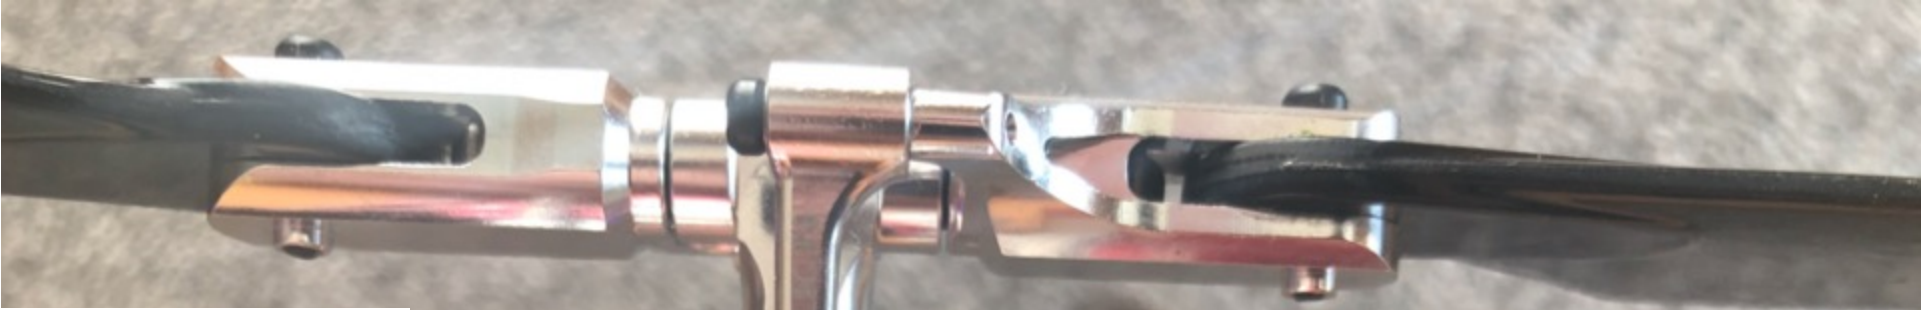
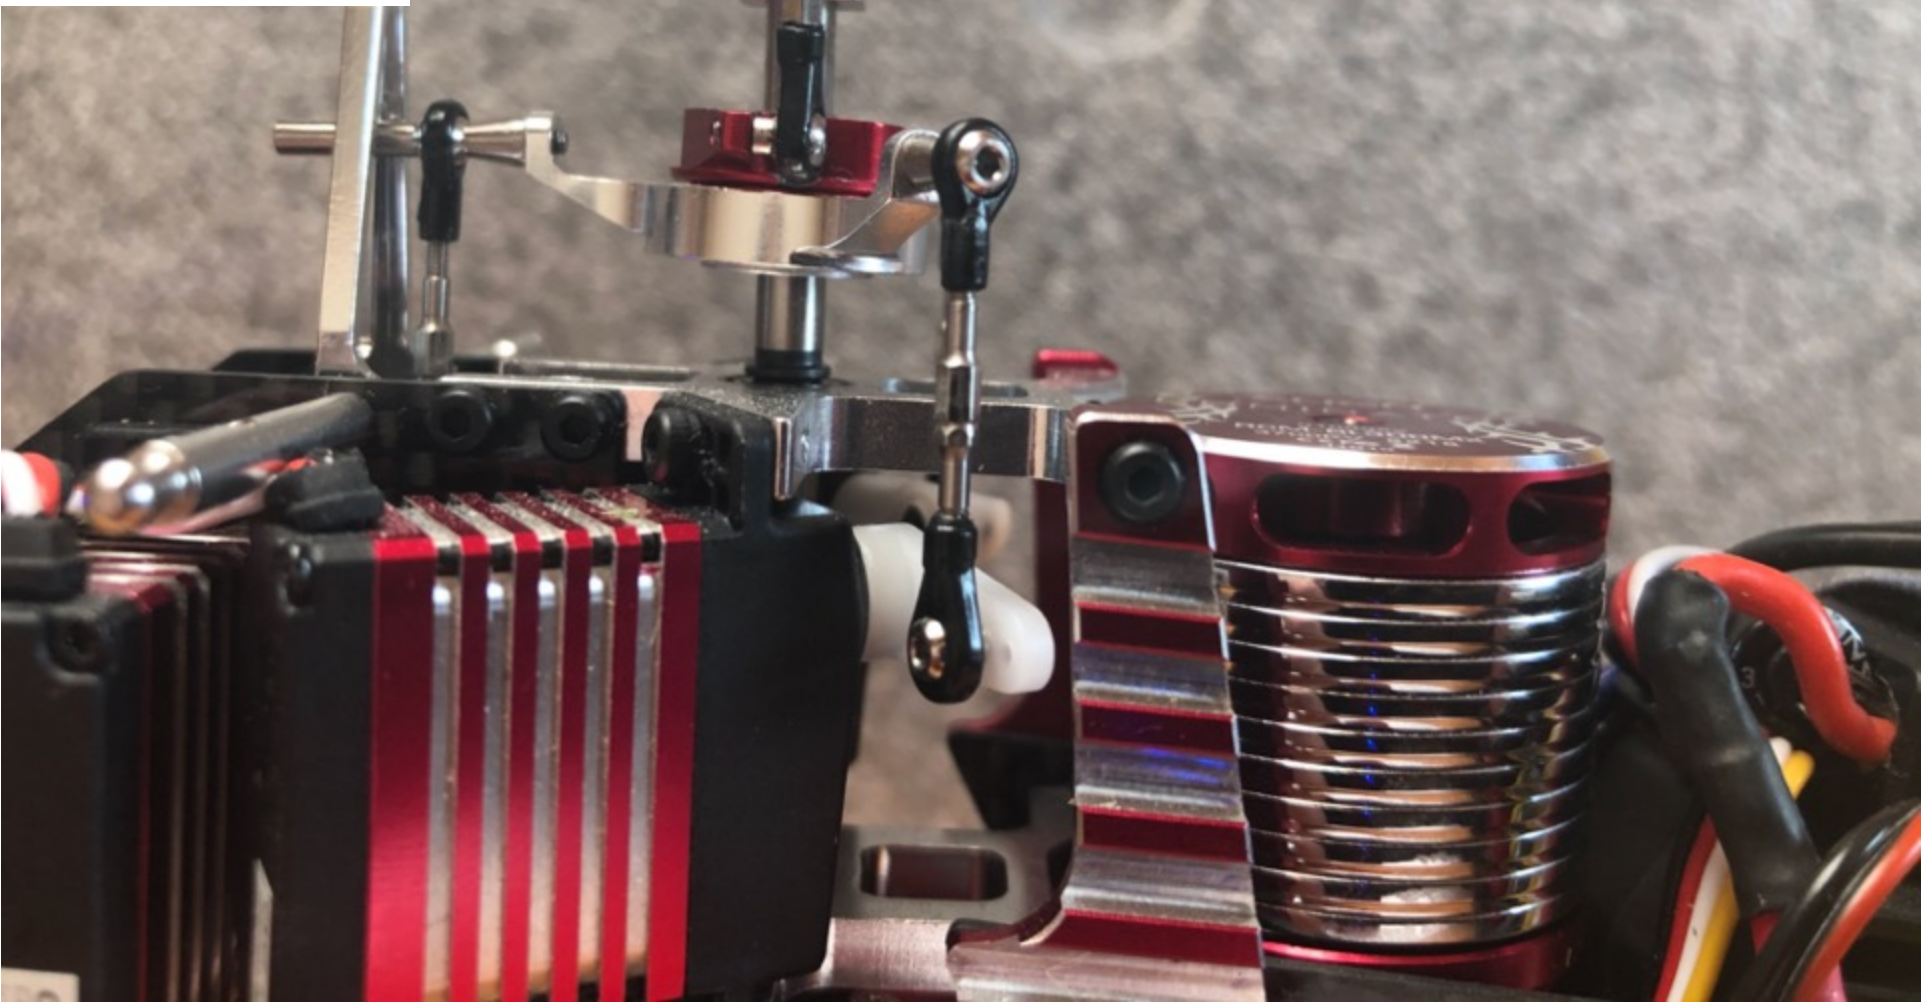
State after initialisation in bank 1
Rotor is not spinning

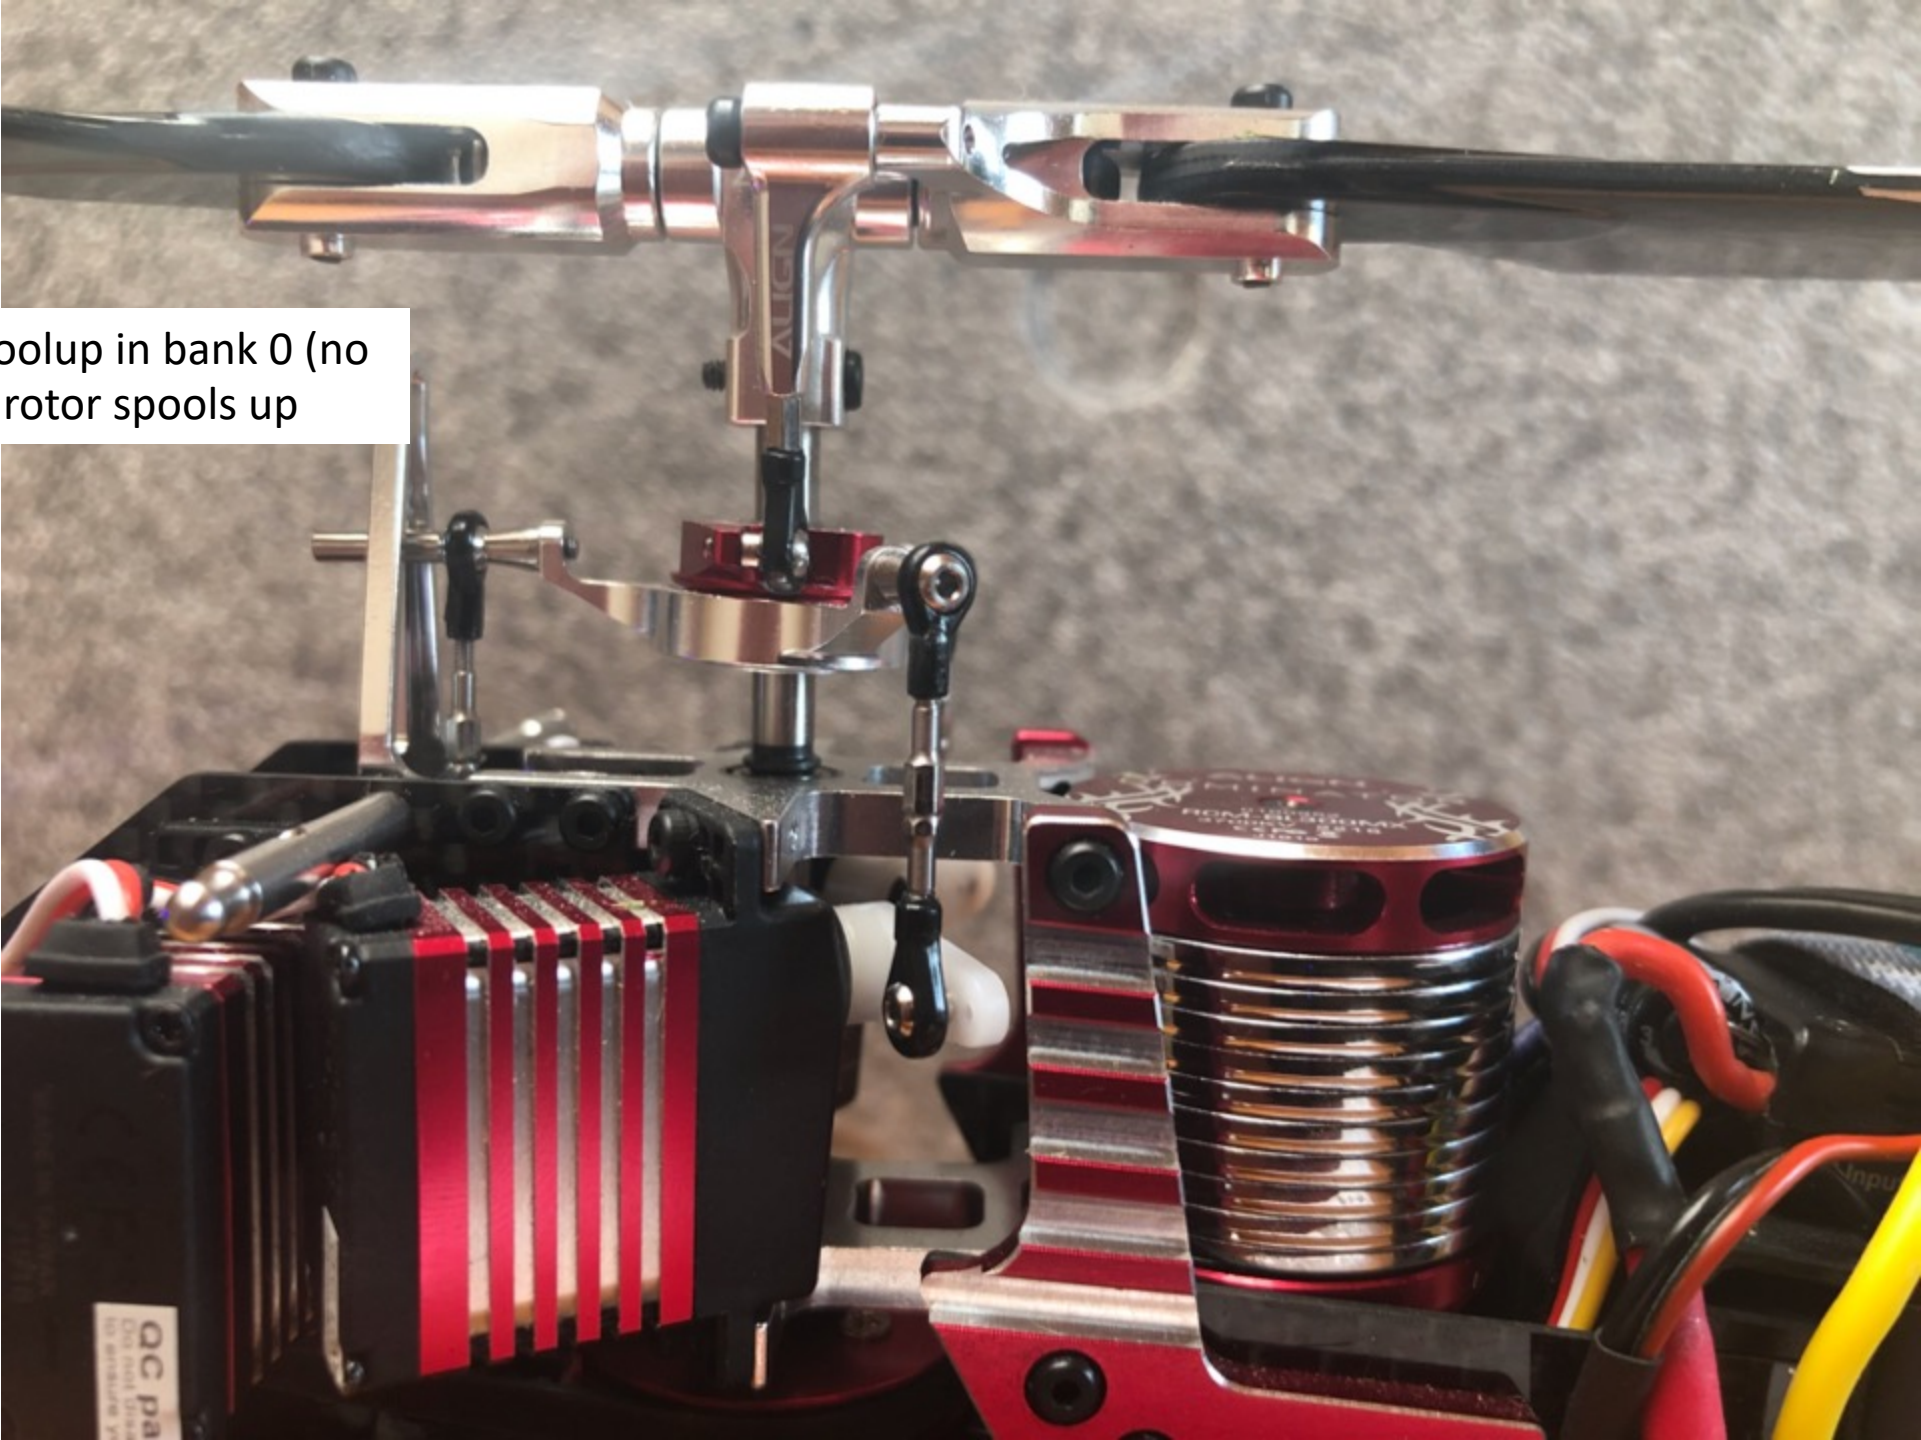
State after spoolup in bank 0 (no stabilisation) rotor spools up

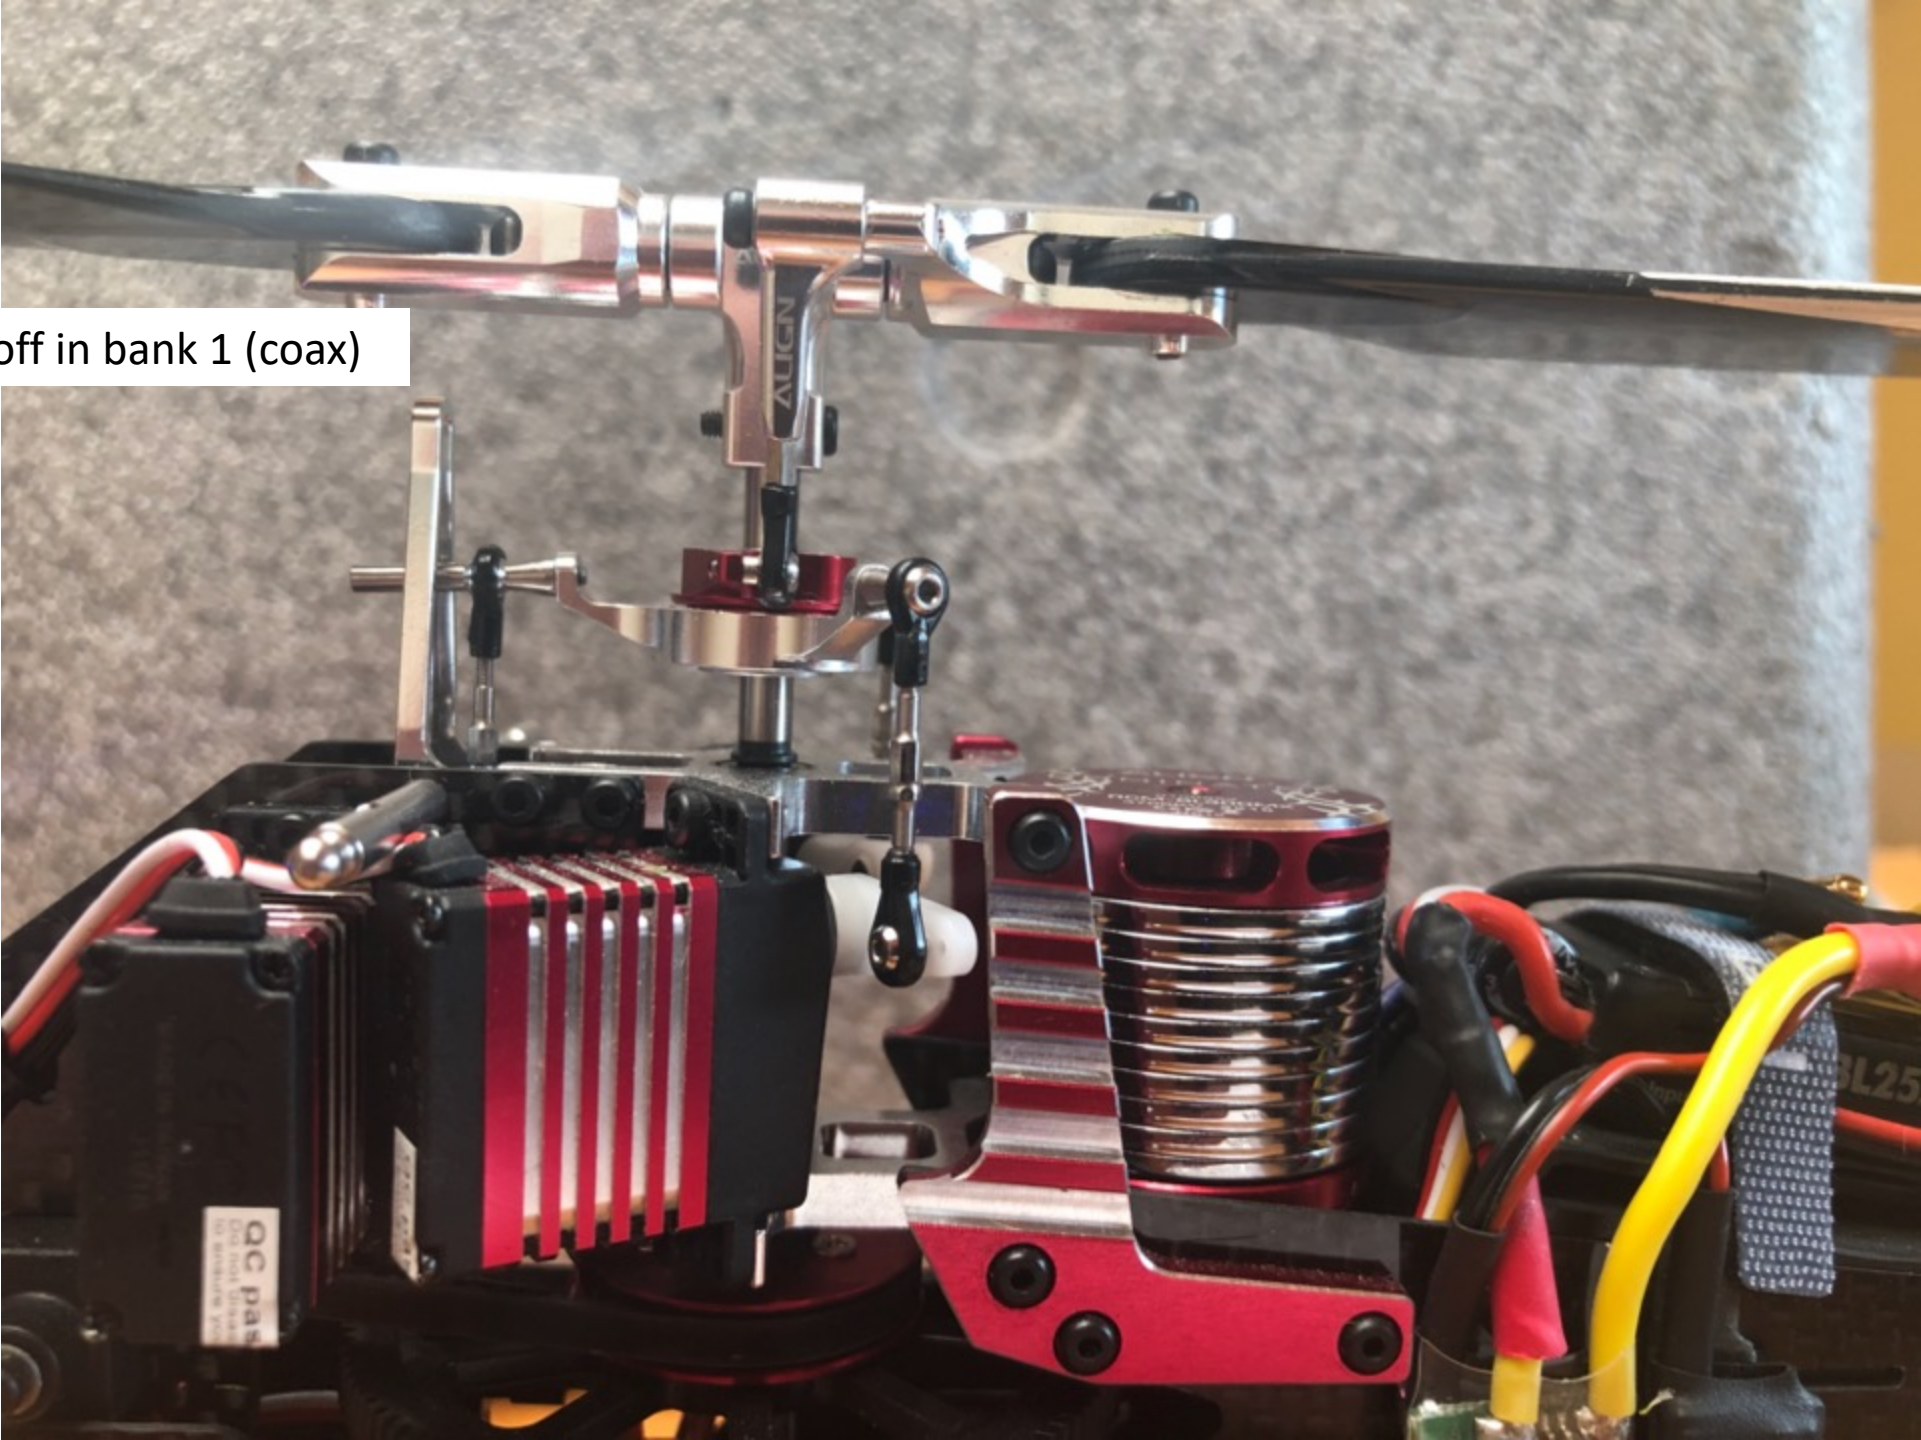
State at take-off in bank 1 (coax)

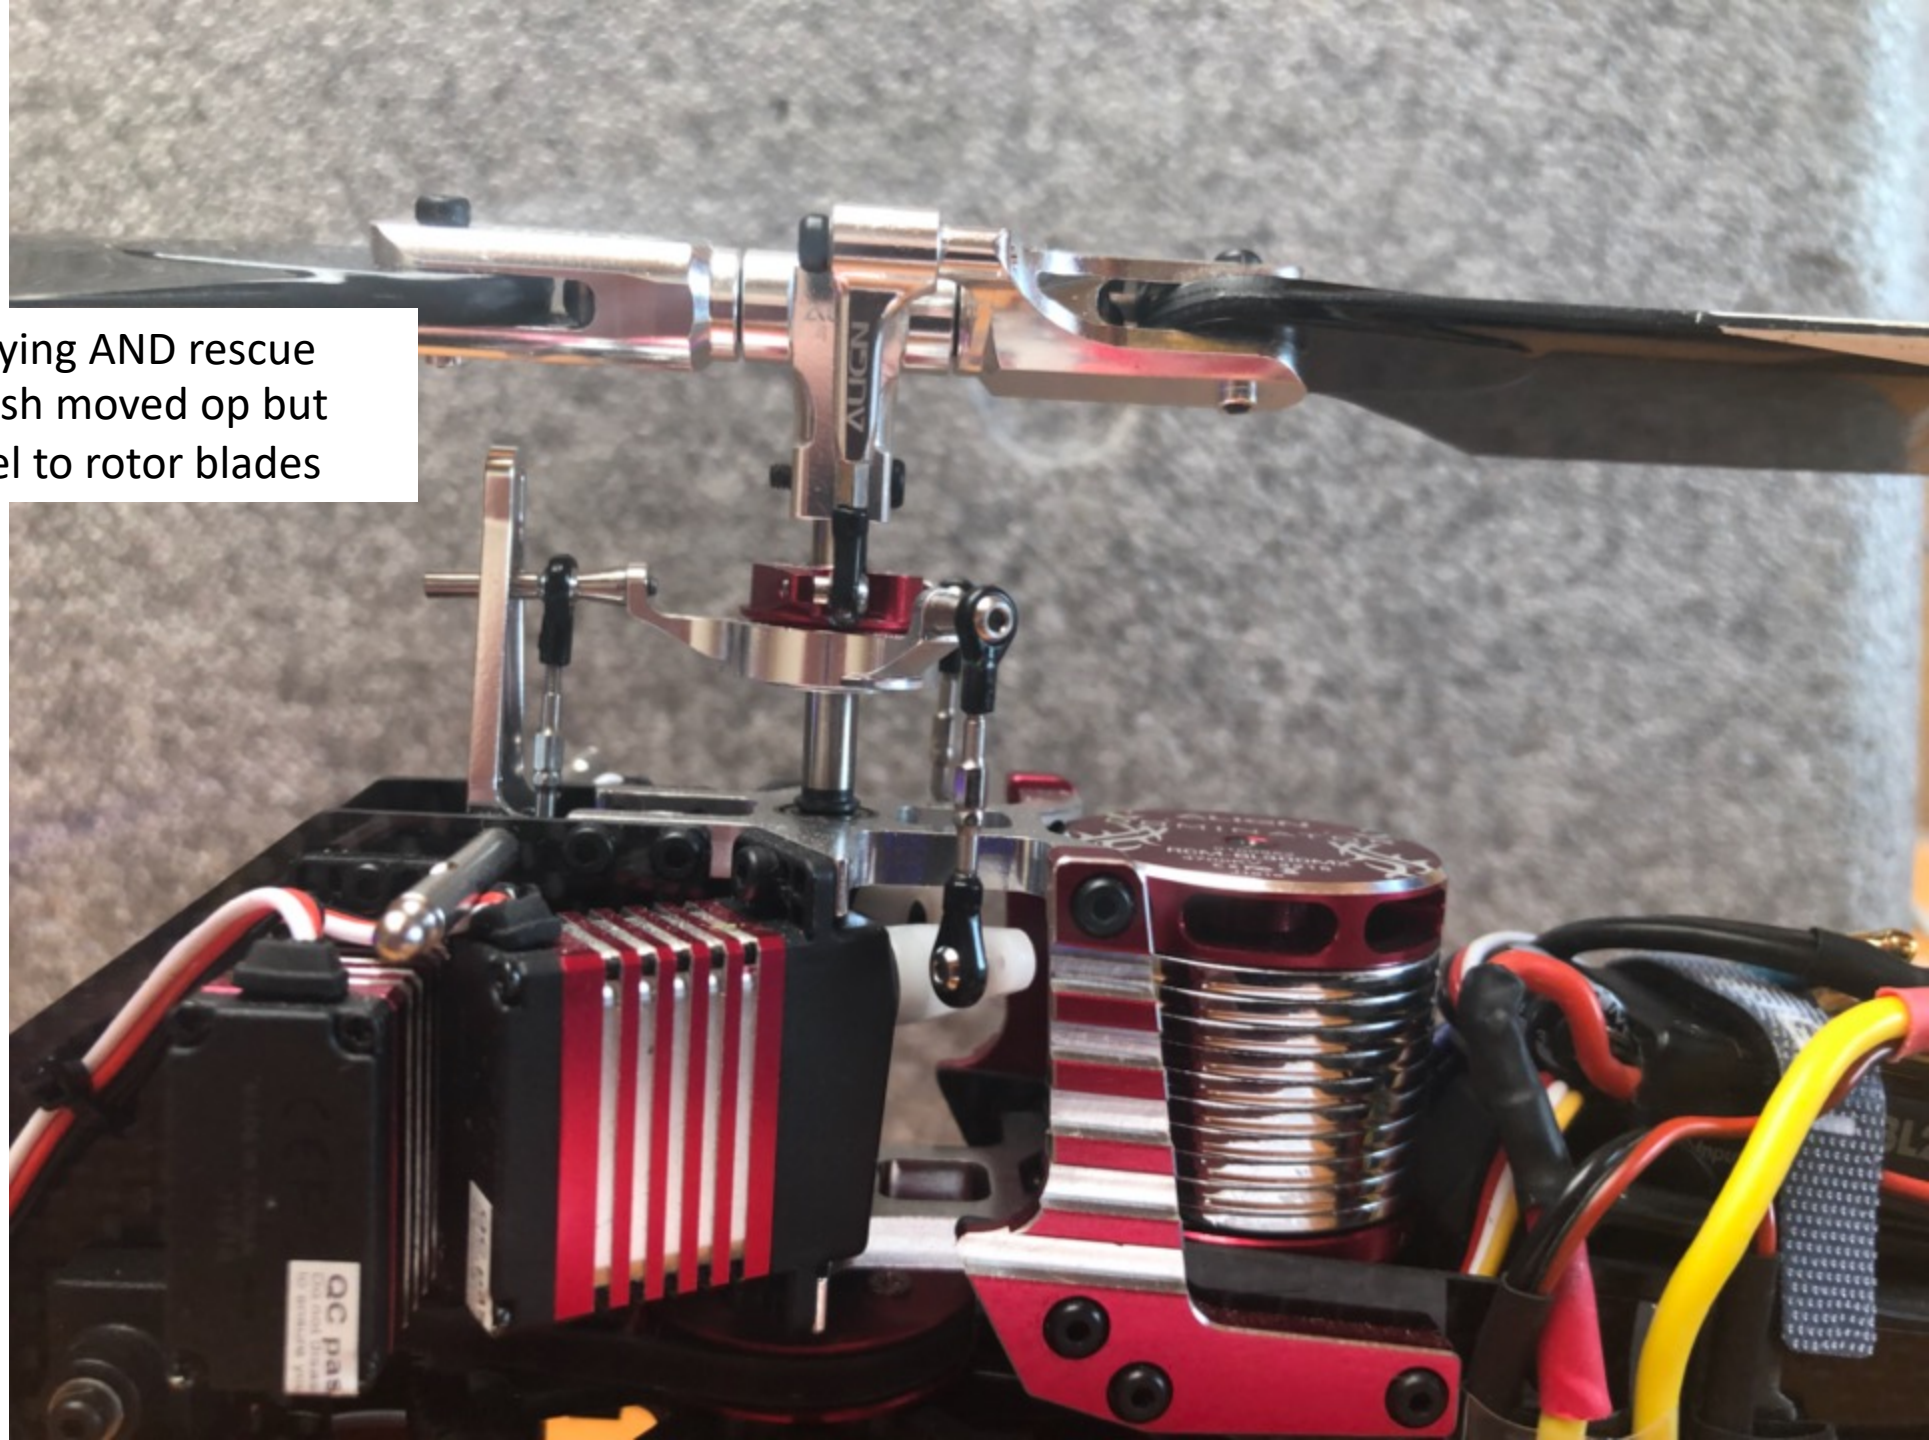
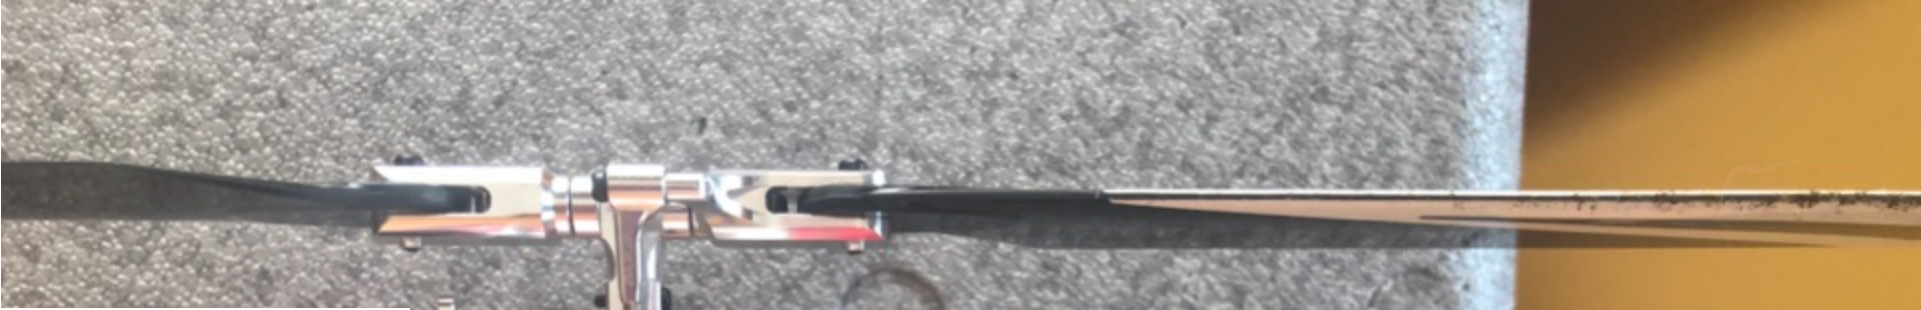
State when flying AND rescue
(bank 2): swash moved up but
stayed parallel to rotor blades

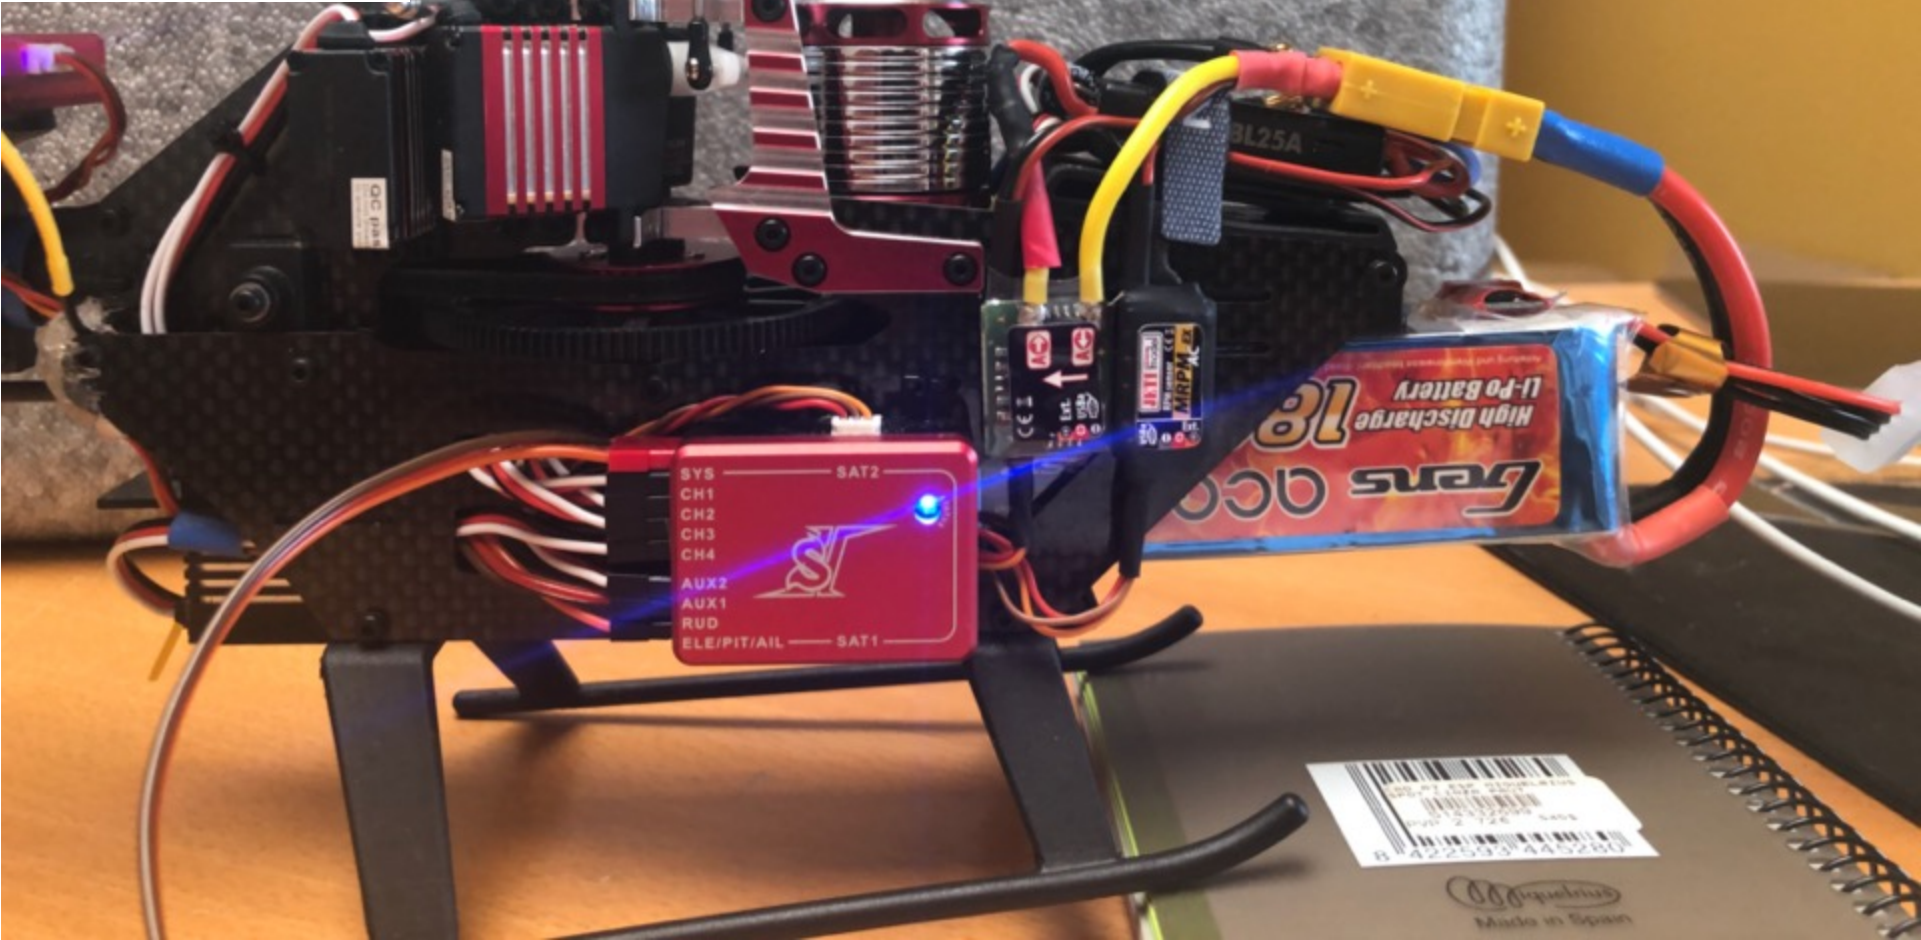
State with main axis vertical,
bank 1

- The correct mounting requires the unit to be parallel to rotor blades
- Because of skids, the heli is inclined by approx. 5° nose down when spooling up and at take off. Swash is then // to rotor blades
- When hovering with main axis vertical, swach is inclined nose down (due to stabilisation / coax). This requires constant correction from the pilot
- With fw 2.8 some almost no correction was needed to hover in place. With fw 3.0 strong correction is needed (roll to the right, nick to aft)
- With fw 3.0 at landing the heli tipped to the right and rotor touched ground
